Management Plans for Conservancy Parks

Village of McFarland
5915 Milwaukee Street
P.O. Box 110
McFarland, Wisconsin 53558

Management Plan for Conservancy Parks Village of McFarland

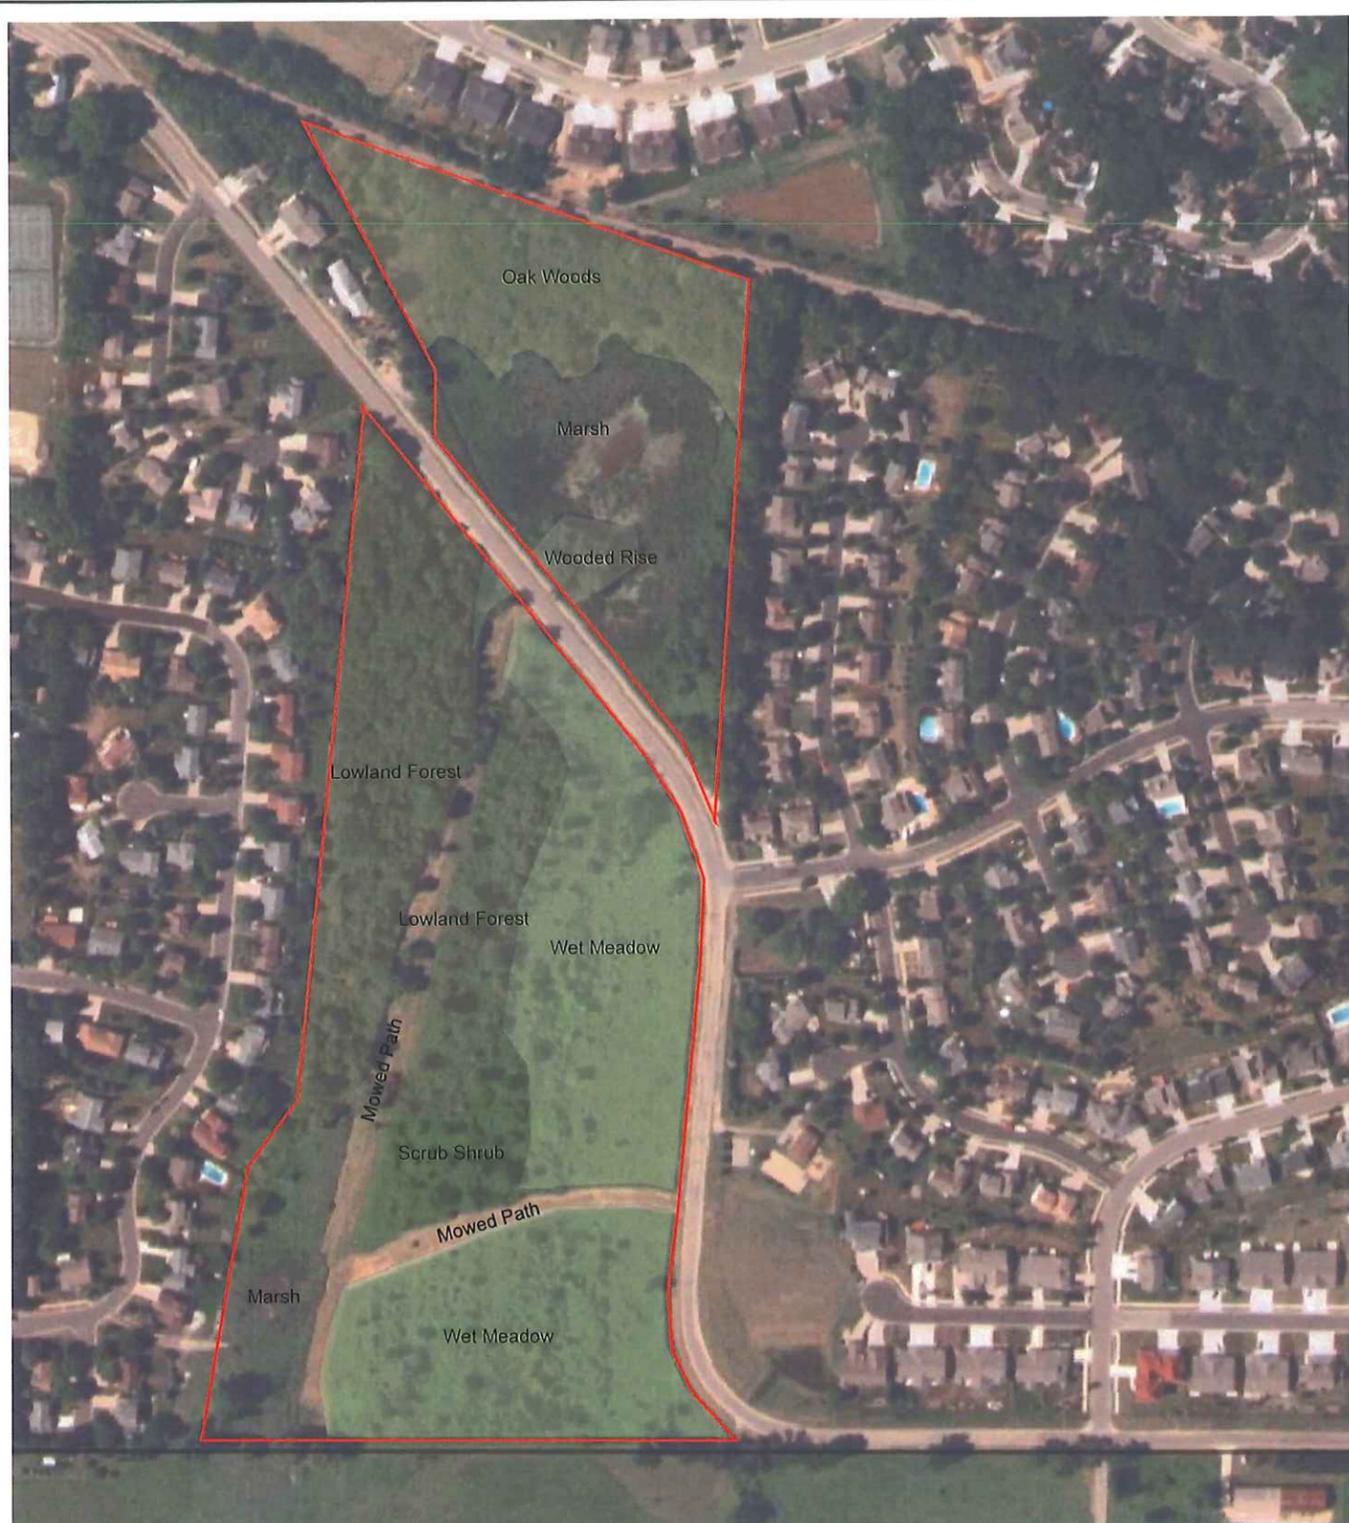
<p>1402 Pankratz Street, Suite 302 Madison, WI 53704 Phone: 608.240.1453 Fax: 608.242.5999 www.jfnew.com</p>	<p>Figure 2. Grandview Conservancy Area</p> <p>Village of McFarland Dane County, Wisconsin</p> <p>1 inch equals 300 feet</p>
---	--	---

Grandview Conservancy Park is an approximately 25 acre park that consists of lowland woods, marsh, wet meadow and oak woods (Figure 2). The park is bisected by Creamery Road, and completely surrounded by residential lots, except to the south, where a hunt club exists. Dividing the southern unit of Grandview Conservancy is a mowed stormwater corridor, with a varied width swale running through it. This corridor serves as a walking path for local pedestrians. The boundaries of the park adjacent to residential areas have been impacted by invasive (primarily ornamental) species, grass clippings and miscellaneous debris. Management activities have occurred in portions of the southern unit, primarily shrub removal and burning within the wet meadow.

The unit is wetter toward the south and east edge of the site. A stormwater swale carries water from the northern unit to the southern unit underneath Creamery Road. The swale empties into the degraded cattail (*Typha* spp.) marsh in the southwest corner of the site. Reed canary grass (*Phalaris arundinacea*) is a codominant within the marsh. Native species present include jewelweed (*Impatiens capensis*), swamp milkweed (*Asclepias incarnata*), rice cut grass (*Leersia oryzoides*), beggar's ticks (*Bidens cernua*), New England aster (*Aster novae-angliae*), spotted Joe Pye Weed (*Eupatorium maculatum*), blue flag iris (*Iris virginica*) and water smartweed (*Polygonum amphibium*). Lowland forest communities that border the path are dominated by early successional trees including box elder (*Acer negundo*), silver maple (*Acer saccharinum*), green ash (*Fraxinus pennsylvanica*), aspen (*Populus tremuloides*) and invasive shrubs including common buckthorn (*Rhamnus cathartica*), multiflora rose (*Rosa multiflora*) and shrub honeysuckle (*Lonicera* spp.). Grey dogwood (*Cornus racemosa*), highbush cranberry (*Viburnum opulus*), elderberry (*Sambucus canadensis*), willow (*Salix* spp.) and riverbank grape (*Vitis riparia*) are found scattered toward the south end of the lowland forest and within the wet meadow. Herbaceous layer within the lowland forest is lacking, but includes scattered sedges (*Carex* spp.), Virginia wild rye (*Elymus virginicus*) poison ivy (*Rhus radicans*) and garlic mustard (*Alliaria petiolata*) particularly along the western boundary with residences. In general, towards the south, fewer trees make way for scattered shrubs and a greater abundance of wet meadow species. Past management activities including woody species removal and burning are evident in the wet meadow where a greater diversity of wet prairie species are present south and east of the paths. While reed canary grass and tall goldenrod (*Solidago altissima*) are by far the most prevalent throughout the wet meadow, there are desirable wet prairie species present. These include big bluestem (*Andropogon gerardii*), obedient plant (*Physostegia virginiana*), bergamot (*Monarda fistulosa*), boneset (*Eupatorium perfoliatum*), swamp aster (*Aster puniceus*), prairie cordgrass (*Spartina pectinata*), saw tooth sunflower (*Helianthus grosseserratus*), and swamp milkweed (*Asclepias incarnata*). Small bur oak (*Quercus macrocarpa*) individuals are scattered south of the path.

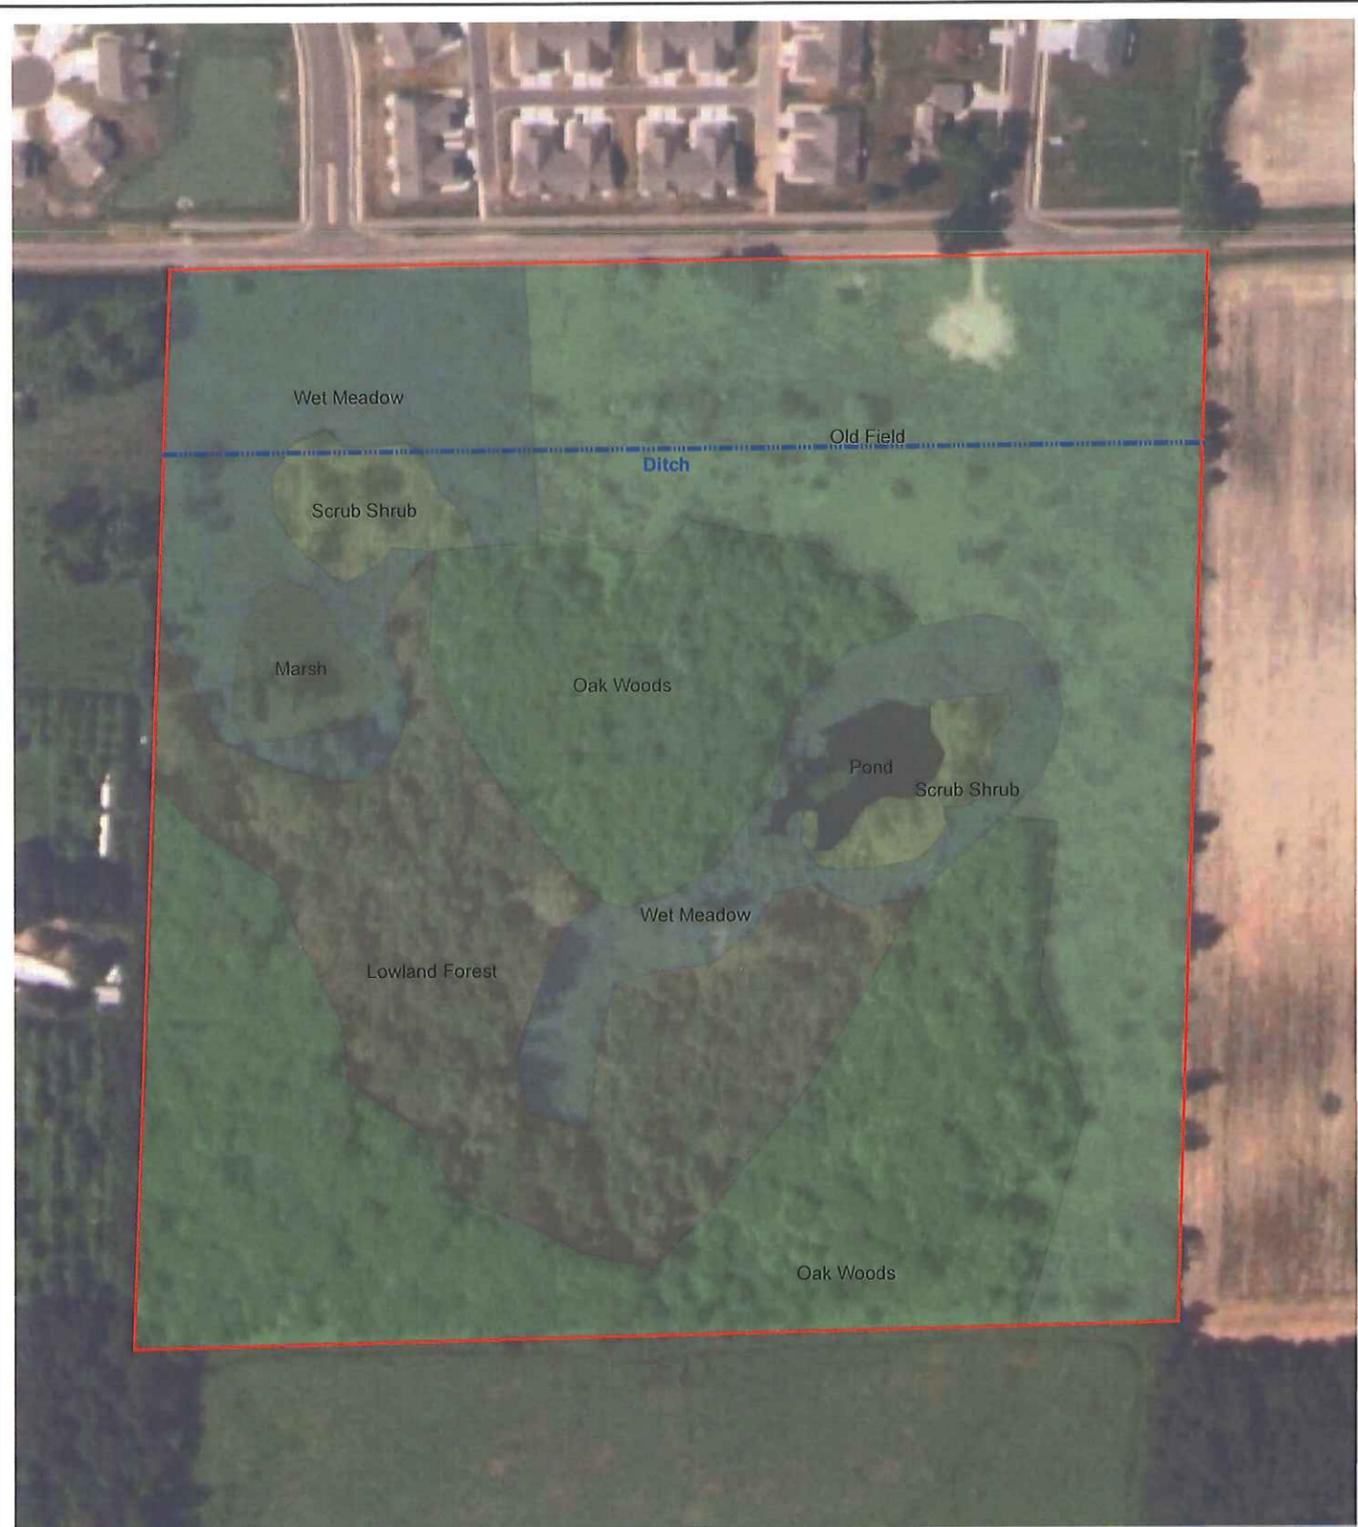
John Urso Community Park is an approximately 39 acre park that consists of old field, wet meadow, lowland forest, scrub shrub, pond, marsh and oak woods (Figure 3). To the north is Elvehjem Road, to the west is an old apple orchard. Active farm land is present to the east and Dane County Parks owns farmland to the south. An old gravel parking area in the northeast corner of the site off Elvehjem Road is currently torn up and not accessible. There are no trails present throughout the site but bird boxes are present in the old field and around the man-made pond.

A manmade ditch runs east – west to bisect the northern quarter of the site. An average of 1-2' wide and deep, this ditch supports emergent species, and carries existing stormwater from the north during and after heavy rain events. Stormwater enters the site from the northwest through a culvert under Elvehjem Road.

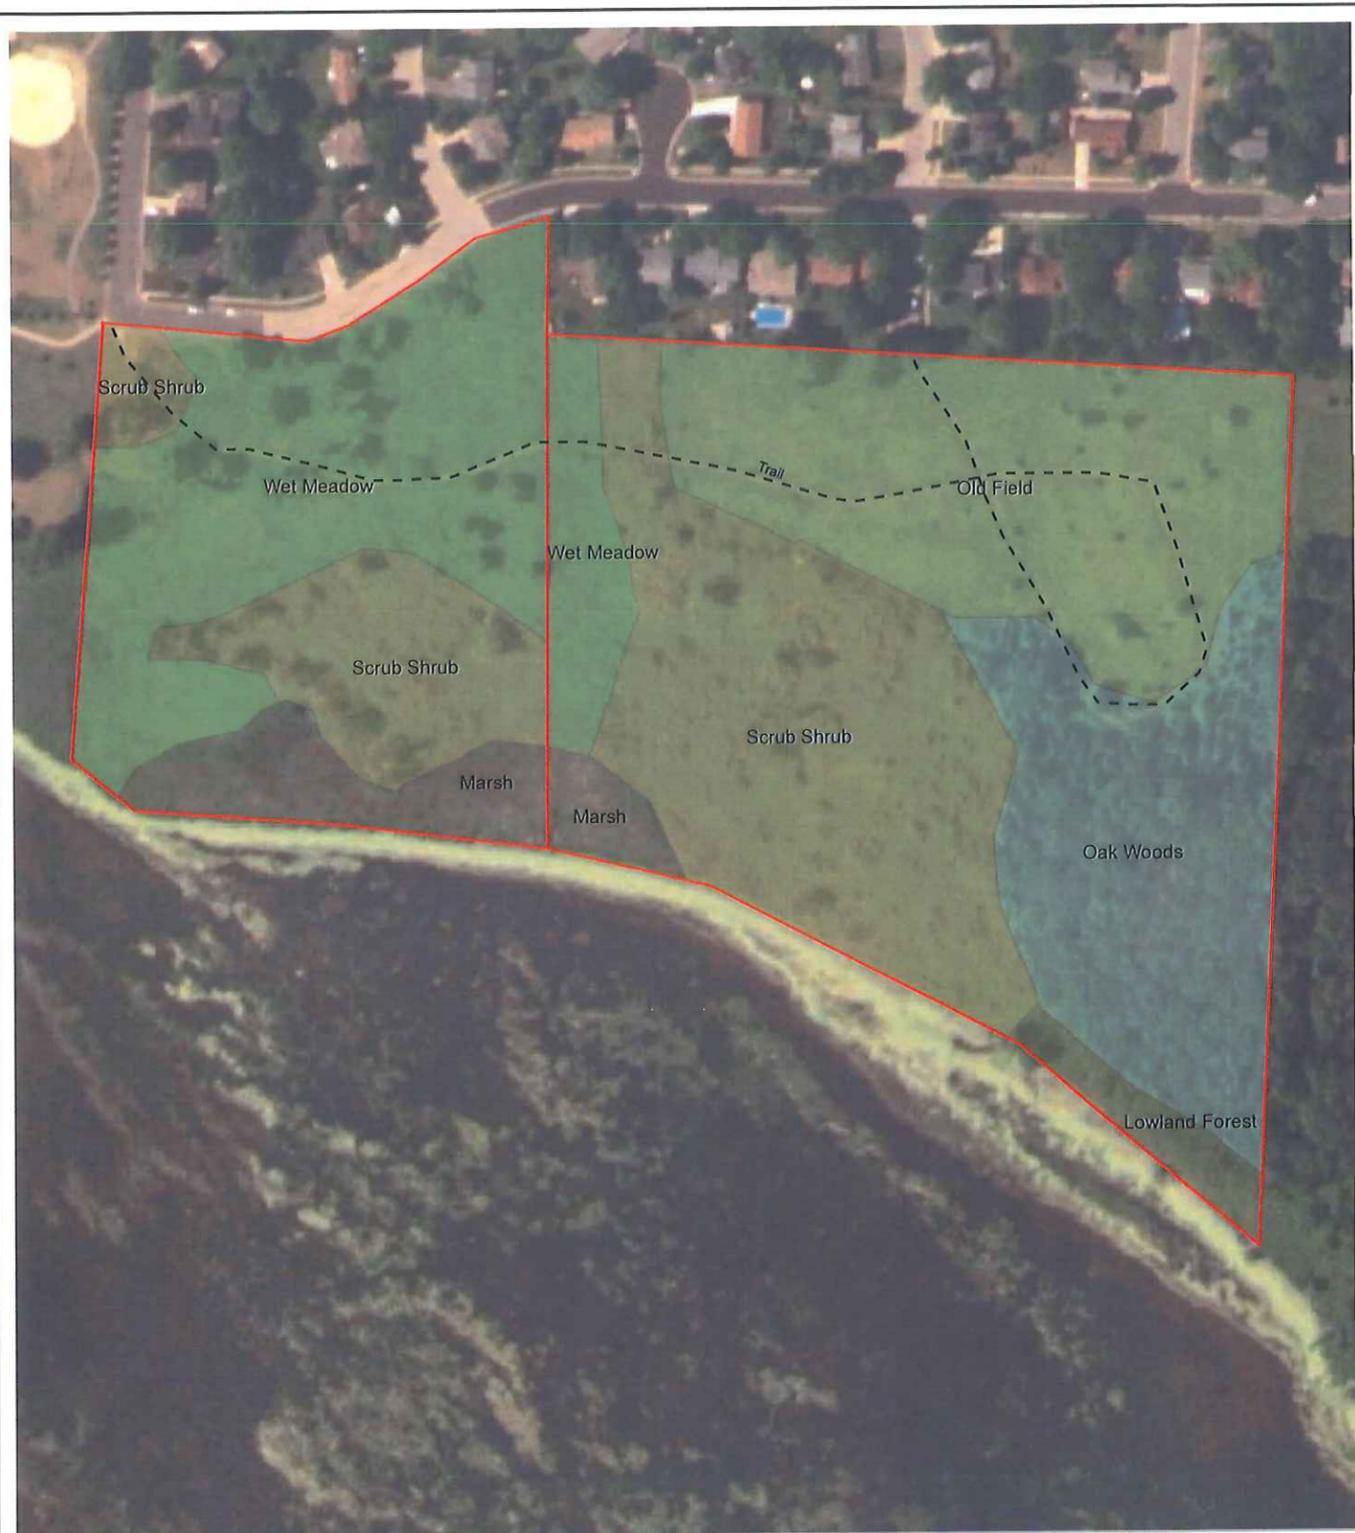
<p>1402 Pankratz Street, Suite 302 Madison, WI 53704 Phone: 608.240.1453 Fax: 608.242.5999 www.jfnew.com</p>	<p>Figure 4. Legion Memorial Park and Marsh Woods Park</p> <p>Village of McFarland Dane County, Wisconsin</p> <p>1 inch equals 220 feet</p>
---	--	--	---

Marsh Woods Park is an approximately 19 acre park that consists of old field, wet meadow, lowland forest, scrub shrub, marsh and oak woods. Adjacent to the west is Legion Memorial Park, approximately 16 acres, with approximately 7 acres as a conservancy park consisting of wet meadow, scrub shrub and marsh (Figure 4). To the north are residential homes and to the south is Lower Mud Lake. There are mowed trails present throughout the wet meadow and old field, with a narrow woodchip path spur into the oak woods.

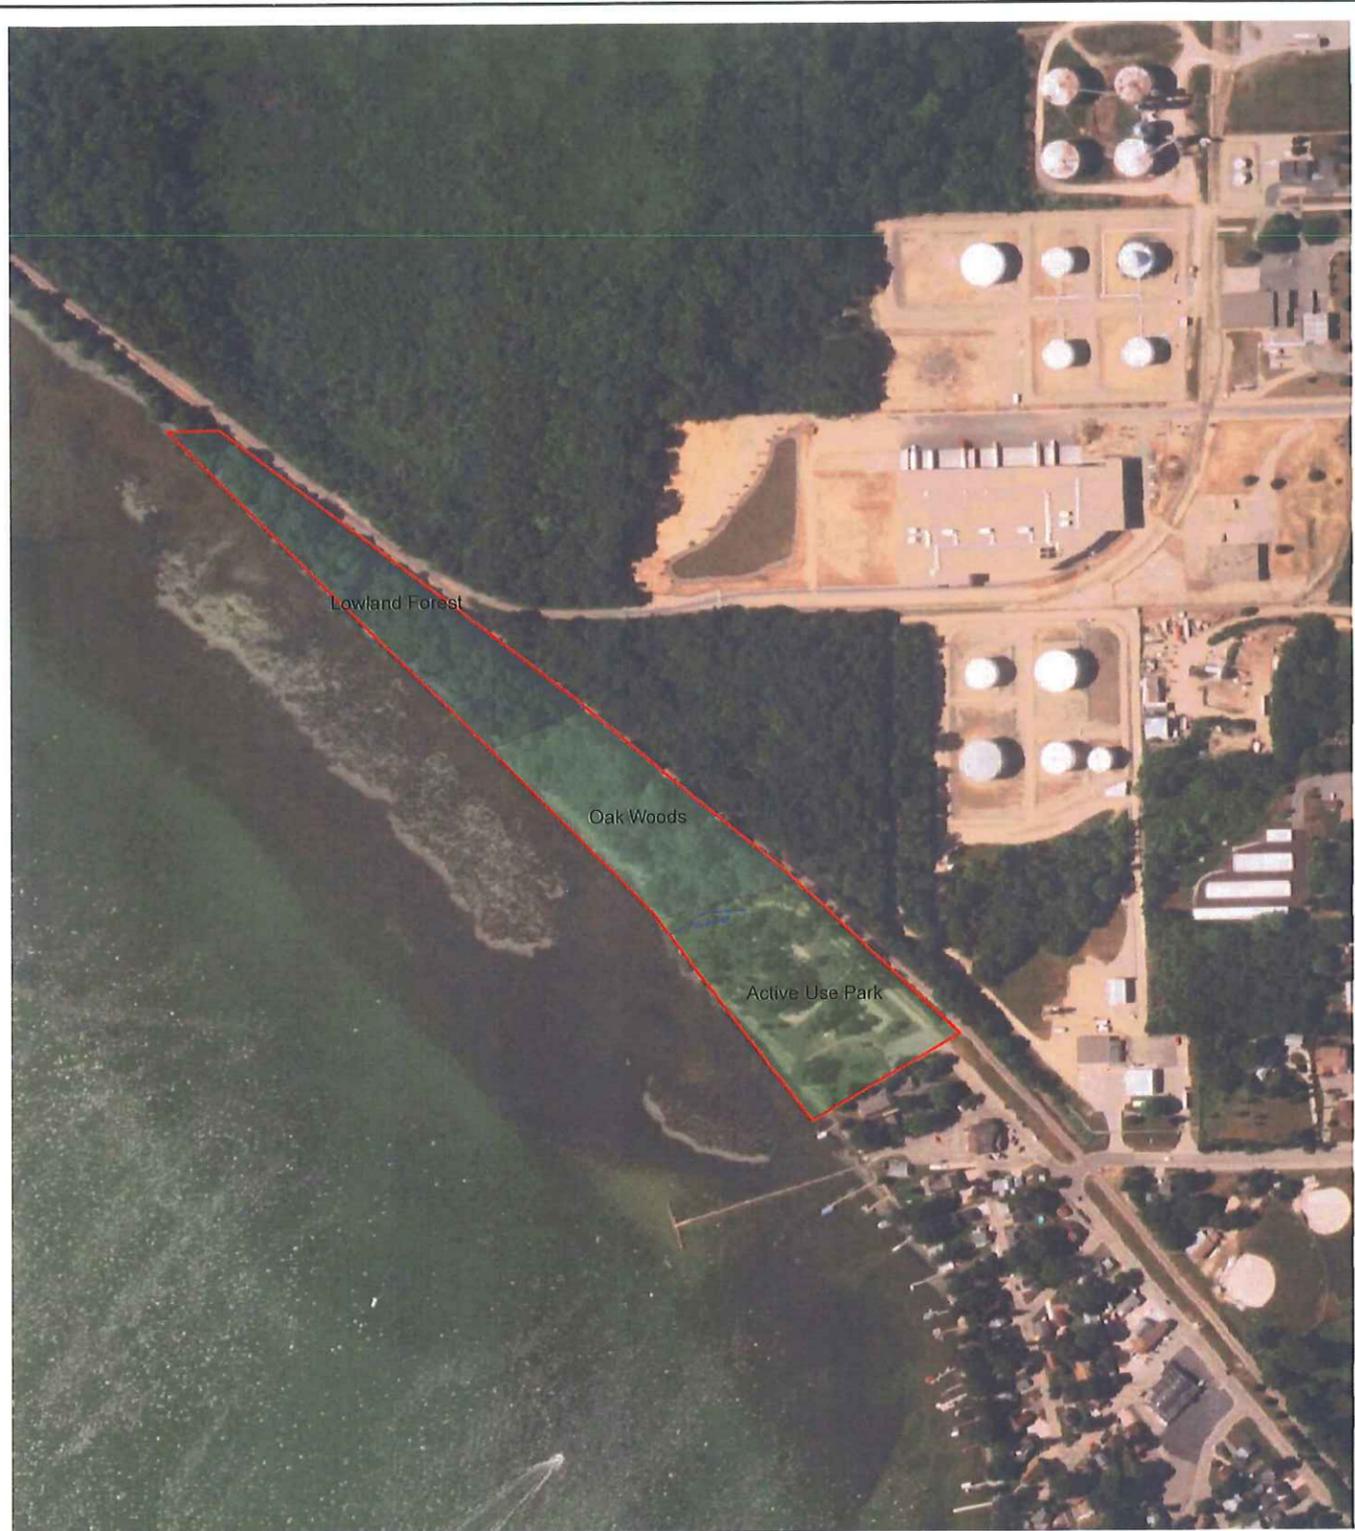
McDaniel Park is approximately 9 acres, with approximately 7 acres as a conservancy park consisting of oak woods and lowland forest (Figure 5). The entrance to the conservancy comes from the active use area to the south, a drainage ditch separates the conservancy area from the active use area. Lake Waubesa borders to the west, an active railroad runs along the east boundary.

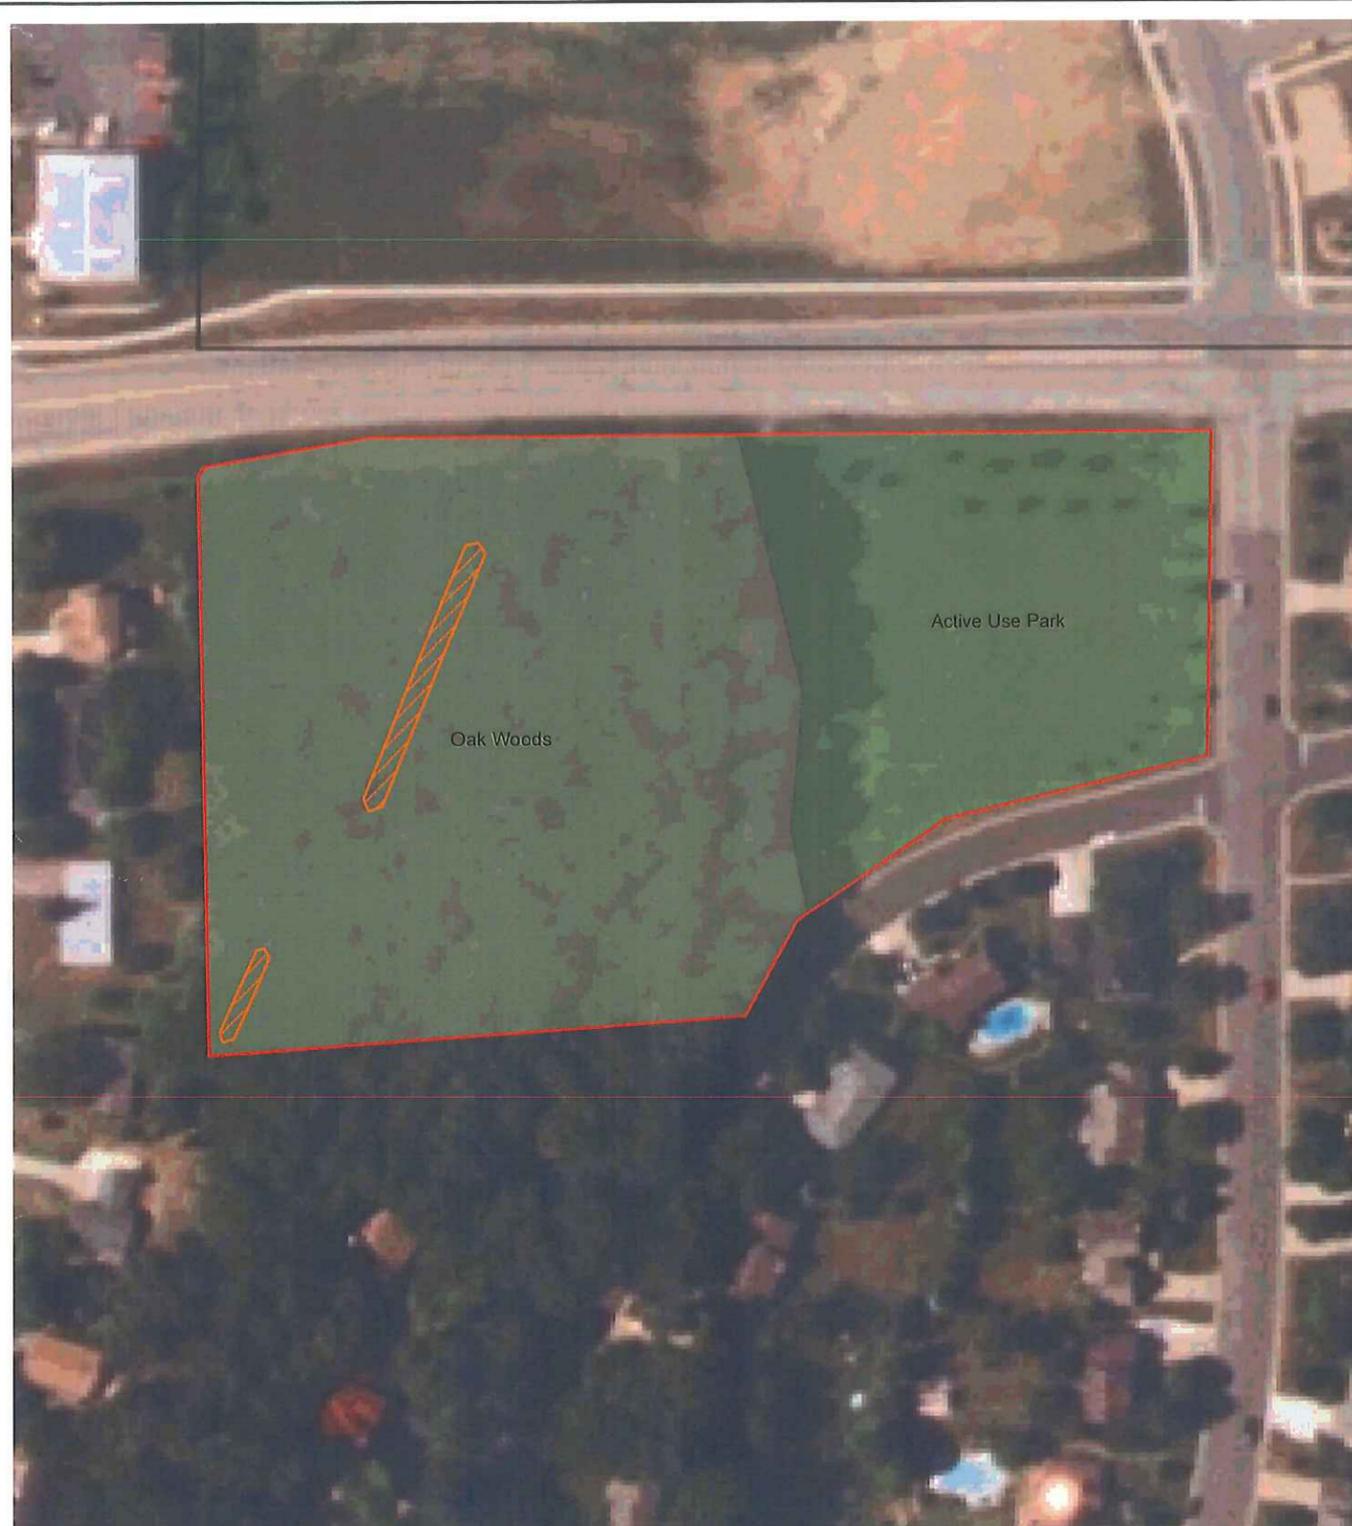
Siggelkow Road Conservancy Park is approximately 5.5 acres of mixed conservancy park and active use park (Figure 6). The east side provides access to the park, which is mowed with planted maples and conifers along the perimeter. Access from the south and west is blocked by residential construction. The north side is restricted by Siggelkow Road and steep road cuts. The west side of the park is dominated by oak woods, rising up to a drumlin that runs north to south across the entire oak woods.

Two linear mounds are present on the top of the drumlin. One large linear mound is oriented roughly NNE to SSW, approximately 60 meters in length, three to four meters in width, and three-quarters meter high. Some trees and shrubs are growing out of this mound. The north end of this mound is within 20 meters of the Siggelkow Road cut. The second mound is location in the southwest corner park. The second mound is oriented NNE to SSW, approximately 20 meters in length, three to four meters in width, and three-quarters meter high.

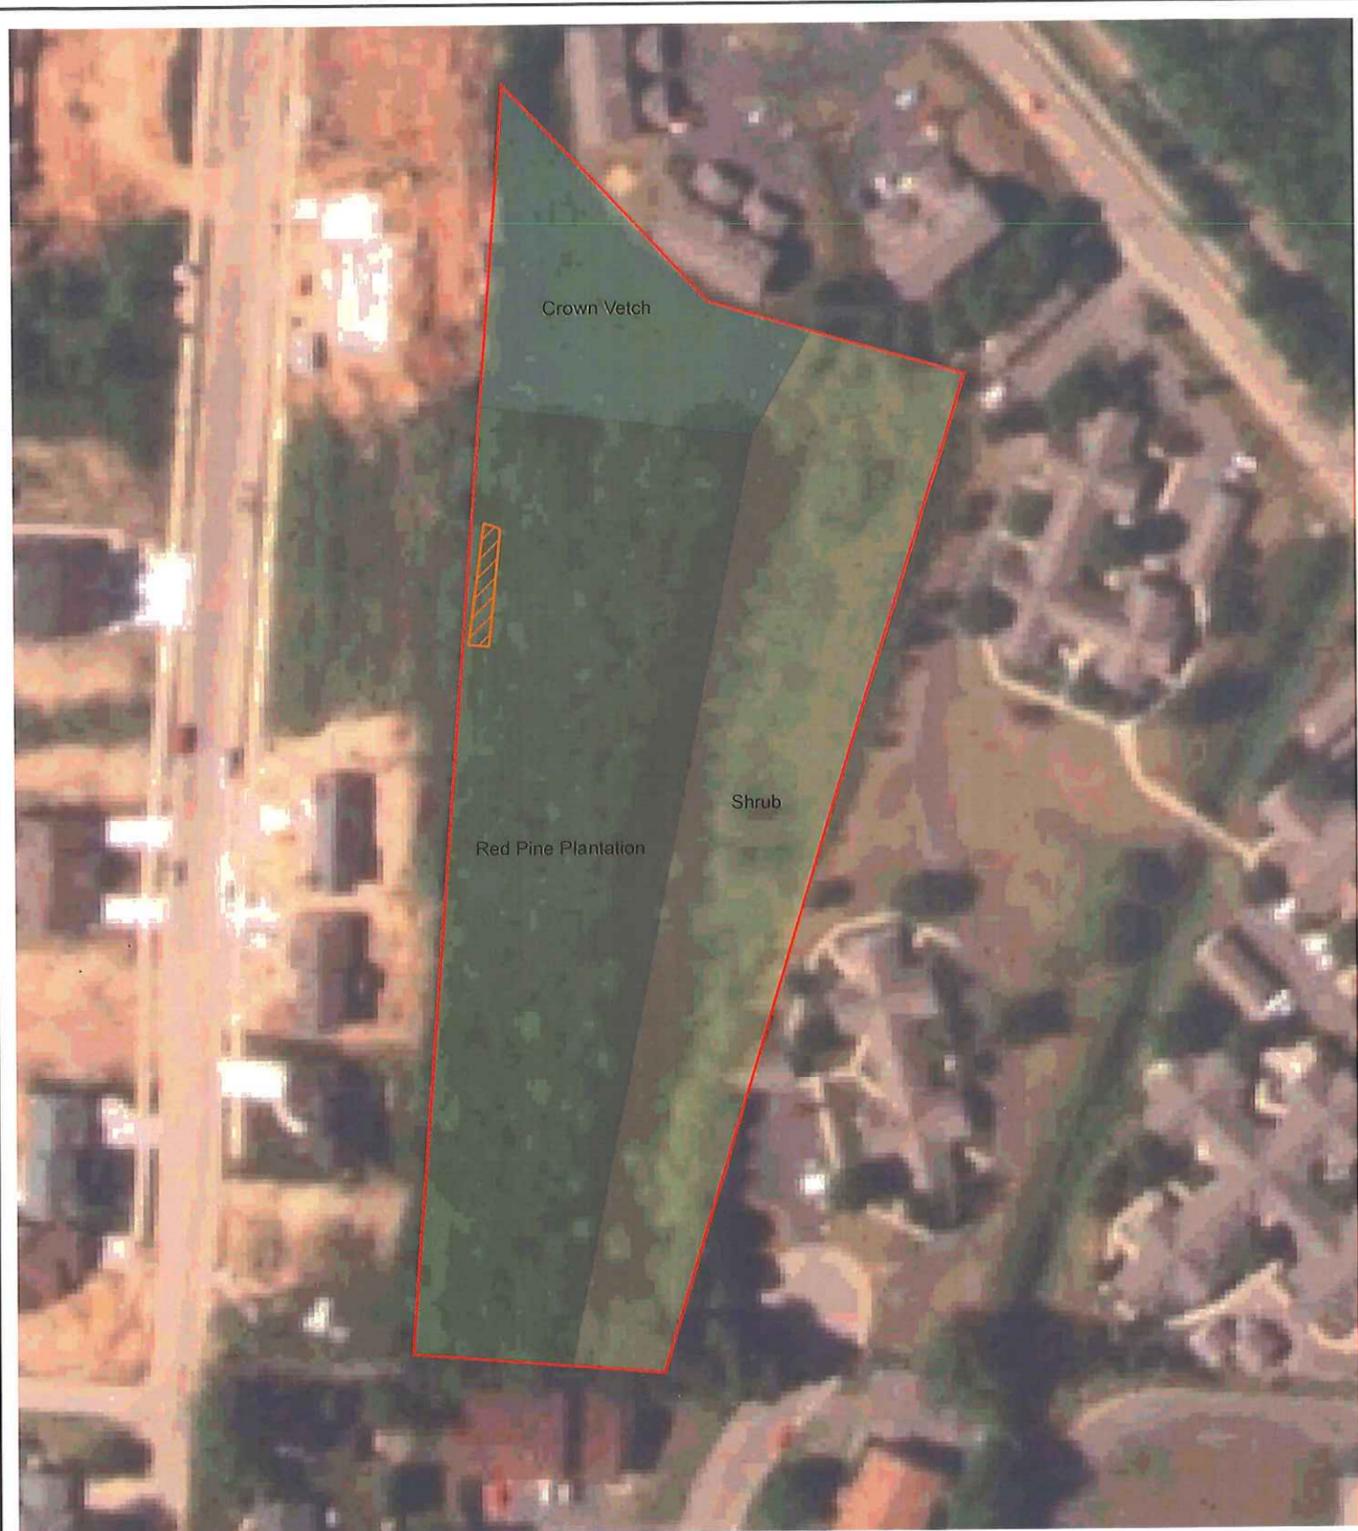
Figure 7. Taylor Road Conservancy Area
Village of McFarland
Dane County, Wisconsin

Taylor Road Conservancy Area is an approximately 6 acre conservancy area that includes a portion of a glacial drumlin hillside (Figure 7). The Conservancy Area is bounded by residential development on all sides. Access to Taylor Road Conservancy Area is possible from a new concrete path located on the west side but is also possible on the east side in an opening between residential developments. Taylor Road Area can be broken into three vegetative areas, none of which support native plant communities. These three vegetative areas are crown vetch (*Coronilla varia*) dominated slope to the north, red pine (*Pinus resinosa*) plantation to the west and steep shrub slope to the east.

One linear mound is present along the western border of the area (west side of the pine plantation). It is oriented roughly N to S, approximately 20 meters in length, three to four meters in width, and three-quarters meter high. Because of its close proximity to the boundary of the property, there is concern that it could be impacted by future earthmoving activities associated with the residential development to the west.

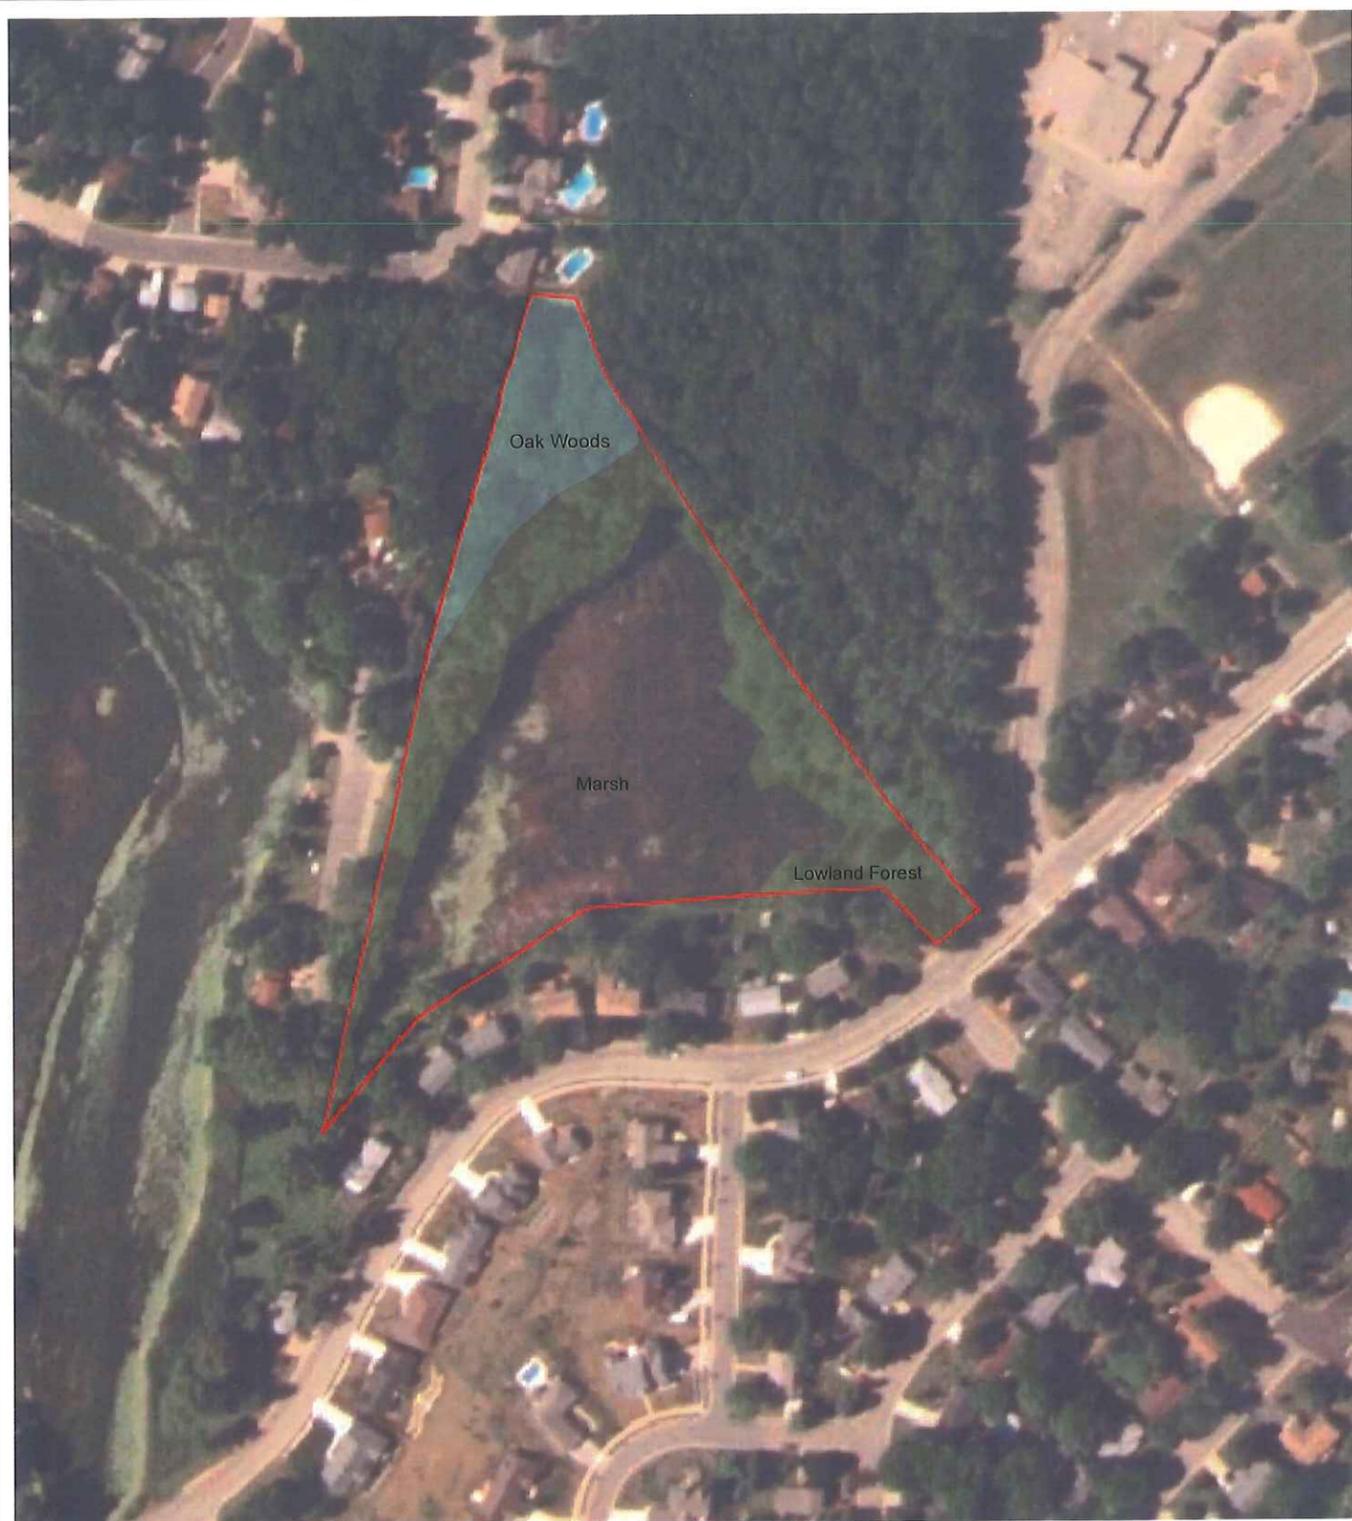
Thrun Marsh is an approximately 6 acre park that consists of oak woods, lowland forest and marsh. Adjacent to the north is the Indian Mound School Forest (Figure 8). To the south is a residential row of houses, to the east is the active recreation area for the school and to the west is Conrad Jaeger Park adjacent to the Yahara River. A small foot trail runs along the north side of the conservancy park. Management, primarily removal of buckthorn and shrub honeysuckle have occurred throughout the oak woods and lowland forest.

An outlet carries stormwater drainage into the conservancy park from the east through the oak woods and lowland forest, crossing trails and causing erosion. In addition, an outlet carries stormwater into the northwest shore of the marsh.

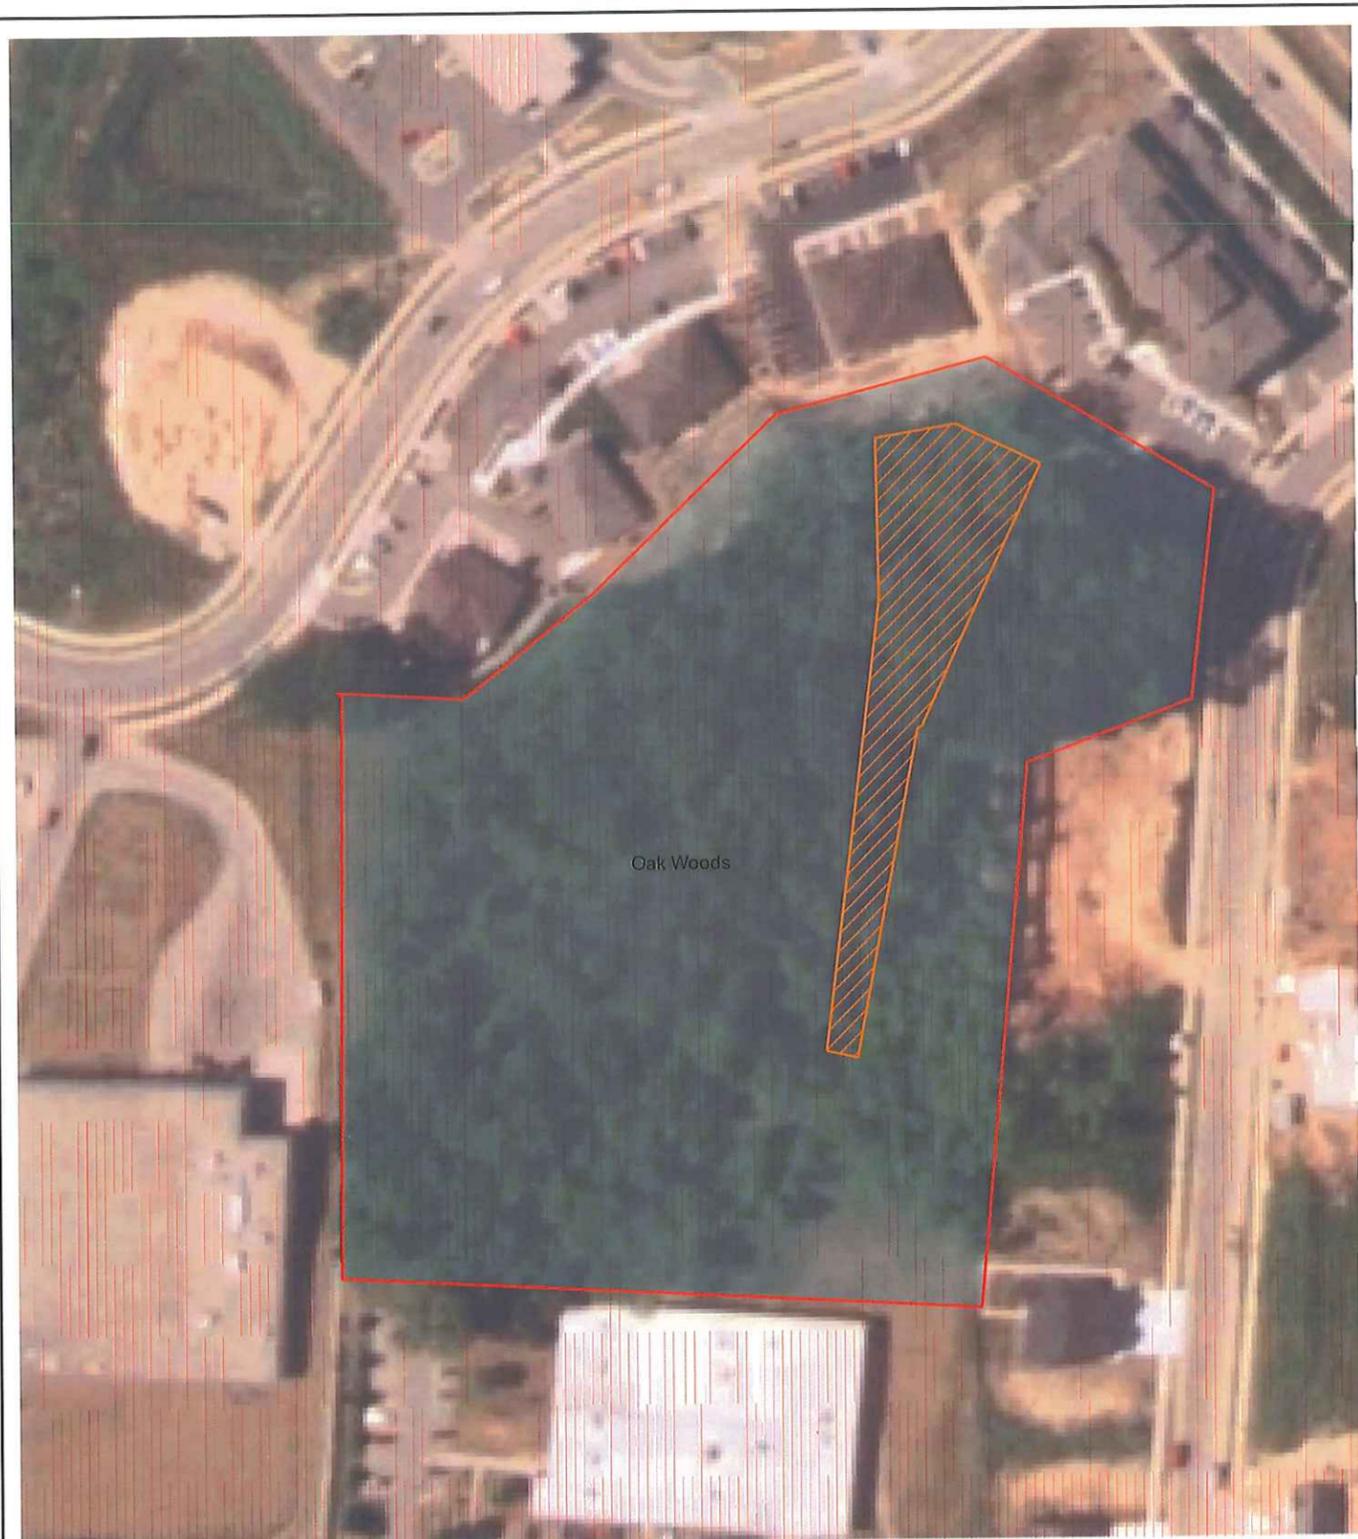
Woodland Commons Park is an approximately 5 acre park that consists of various quality oak woods on a glacial drumlin (Figure 9). The park is surrounded by residential and commercial land on all sides. Commercial land exists to the west and south, residential primarily to the north and east. New construction has cut into the drumlin to the west and a recent retaining wall has been constructed. Access is limited to a narrow area along Lexington Road along the northeast side.

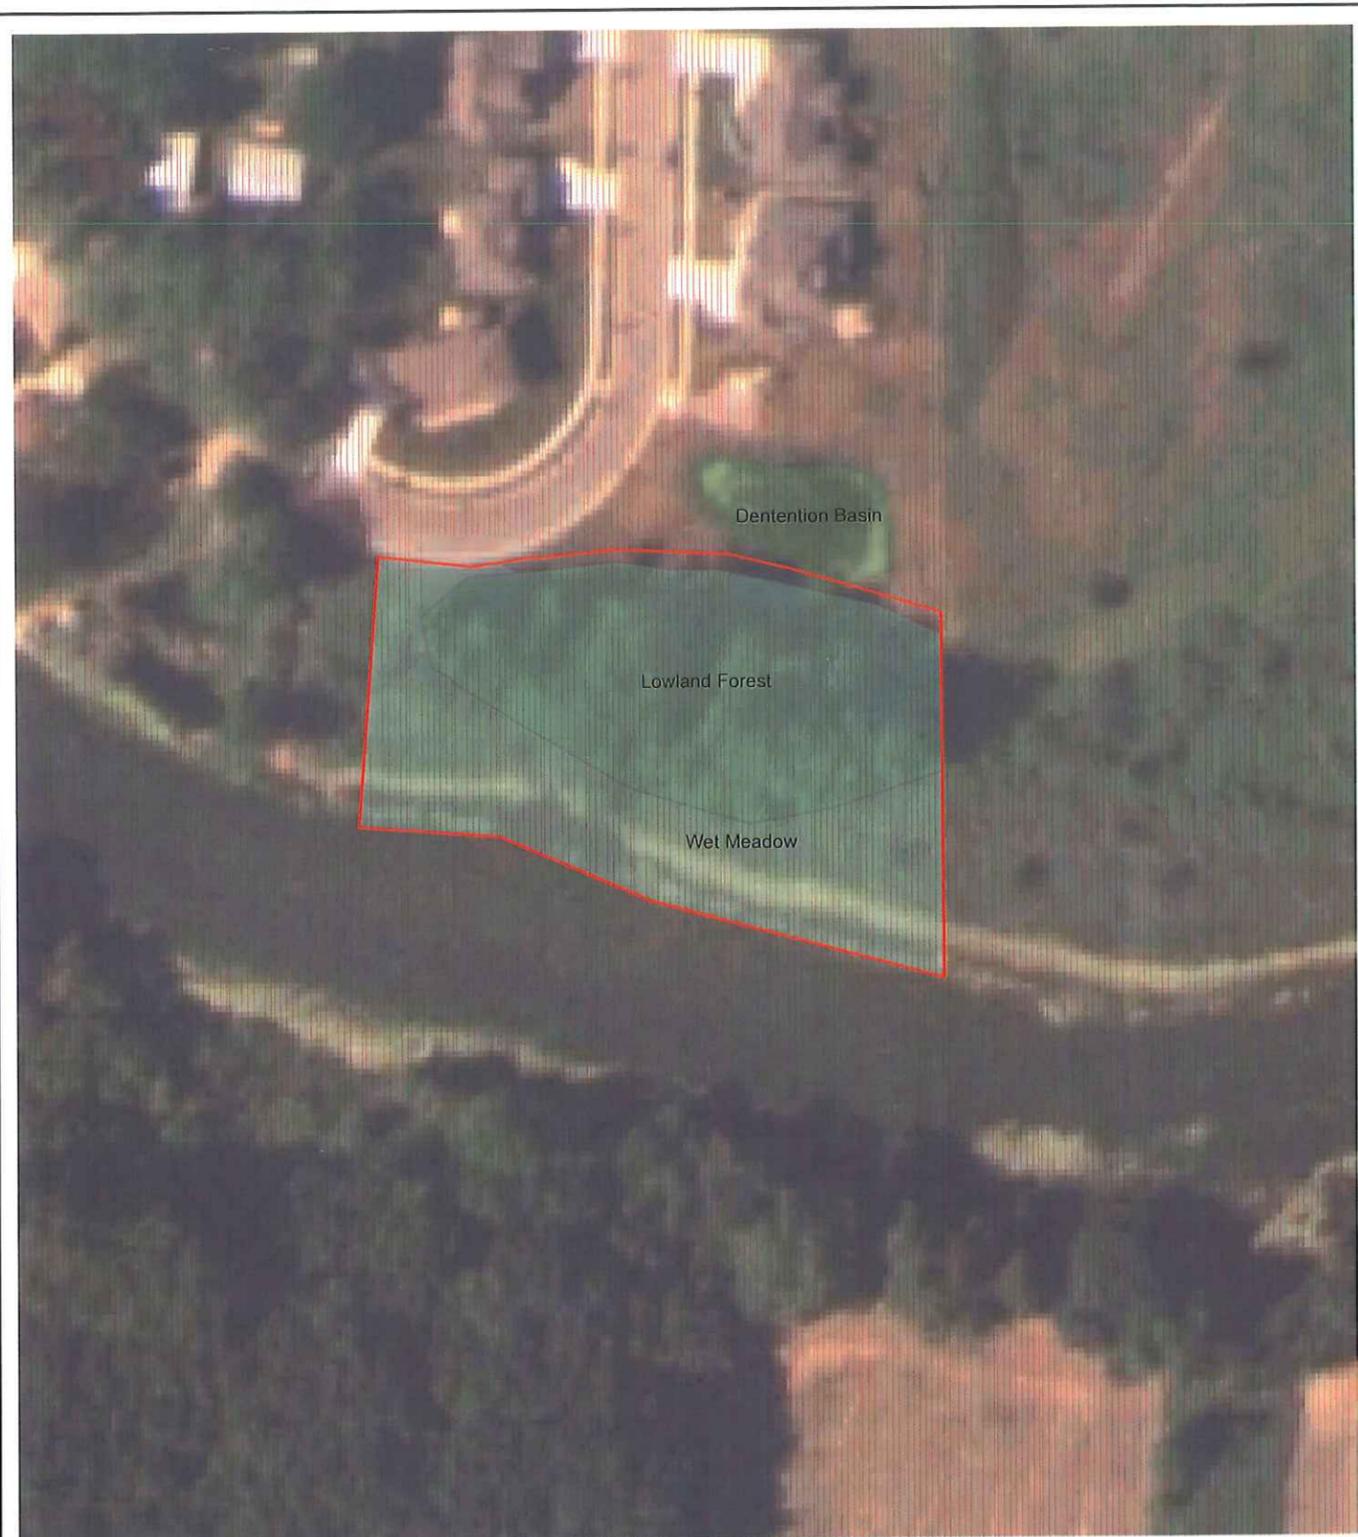
Yahara River Park is an approximately 1.5 acre park with an adjoining detention basin to the north. The park consists primarily of lowland forest and wet meadow (Figure 10). Active management, via invasive shrub removal has occurred in the past. Adjacent to the north is residential, and to the west and east is a continuation of the degraded lowland forest. The Yahara River borders to the south. A small gravel trail runs south along the western property boundary, from the residential road to the river.
